## Street Light Column Outside 3, Duloe

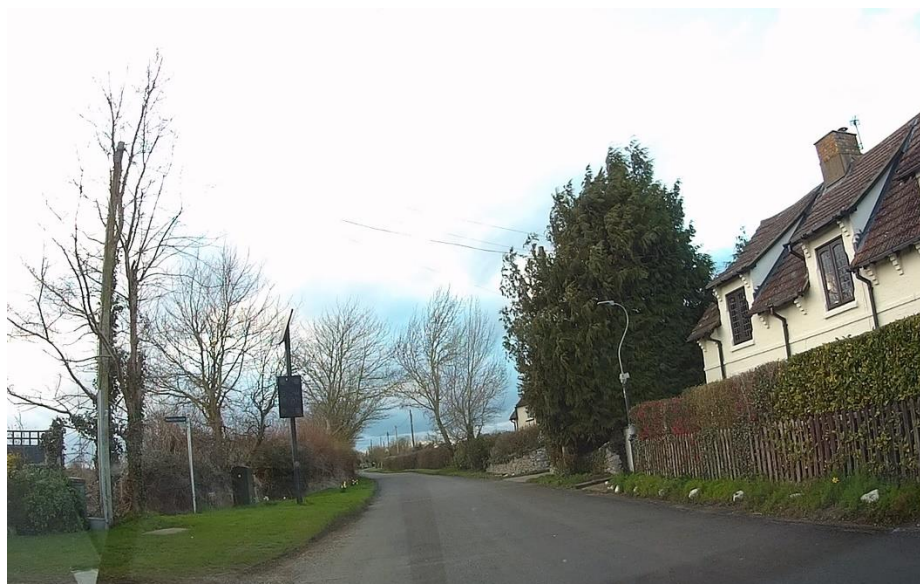
Staploe Parish Council own and maintain 21 street lights in the parish. 20 of these are mounted on brackets on telegraph poles but one is a cast iron street light column located outside 3, Duloe.

He did a visual inspection of the street light column outside 3, Duloe and said that it looks sound at the moment but there are two issues with these columns.

1. The cast iron can become brittle and shatter if hit by a car which can do a lot of damage to the car and its occupants (but as he said if someone hits a cast iron lamp post they will probably be damaged anyway).
2. The joint where the swan neck meets the cast iron post can be weakened in the wind and crack in which case the swan neck part might fall and could potentially hit the edge of the house. There is no way to reliably inspect the joint to assess this risk.

His informal opinion is that the column is fine and will last many more years. He says these columns are highly sought after and Woburn Parish have kept all of theirs despite pressure from Bedford Borough Council to change them for the past 10 years – and they are all still fine 10 years later.

He has quoted £150-£200 to remove it – and then we would need to pay around £518 to UK Power Networks for the disconnection.

Sadly we can't move it to a nearby telegraph pole because UK Power Networks will no longer accept other people's equipment on their poles so any replacement would need to be a steel column. Moving it would be extremely expensive in view of the need to pay for the disconnection fee of £518 for the old column and a new connection to the new one (possibly around £1200 for the new connection – I am seeking quotes).

Installation of a new steel column is around £600 plus the connection fee.
